Parametric change in Insulation Resistance and Breakdown Voltage of Underground PVC Cables under Accelerated Multistress Aging Conditions

Index Terms-- 1000 Hours Multistress Aging, Breakdown Voltage, Insulation Resistance, PVC Cables, Visual Inspection

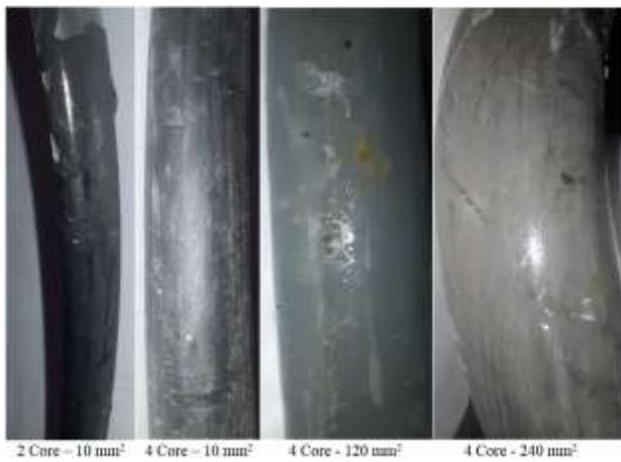
FIGURE 3. Carved out Sheaths window after 100 Hours Aging

Before kicking off the Multistress aging experiment it was advisable and appropriate to check the quality of sheath and then the PVC insulation. There are microscopic excavations, small pores and cavities in the sheath membrane that allows the water ingress from sheath to core. The ingress of water into the

cabling system can have a serious effect on its electrical and dielectric properties. When the cables got wet, its dielectric performance changes which affects the impedance and the related parameters of LC, modulus of elasticity, TS and service life. Figure 3 shows the conditions of four cables after 100 hours thermal aging in water. All four cables were provided with 220 V electrical stress via unit transformer. In chemical stress only heated water was present at 80°C. Electrolytic heating was also done with a 220 VAC source through SS electrodes and water as an electrolyte to bring down the PVC cable's mechanical, electrical and thermal properties to check the resistivity of sheath. Following is the picture of PVC Sheath cut up parts after 100 hours aging was done. As the sheath is made up of impure / recycled PVC so it has passed much water onto the core for this 100 hours period as shown in figure 3. But PVC core is made up of pure, cavity less and tough PVC material that would not lose its resistivity properties with water and moisture prematurely. On removing these 6 inch sheath window, it can be seen that little amount of water has been seeped through it.

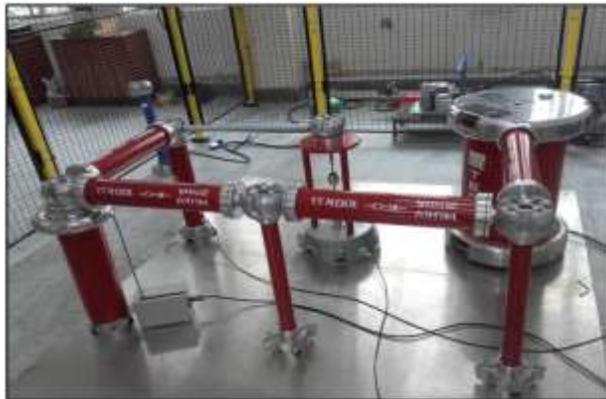
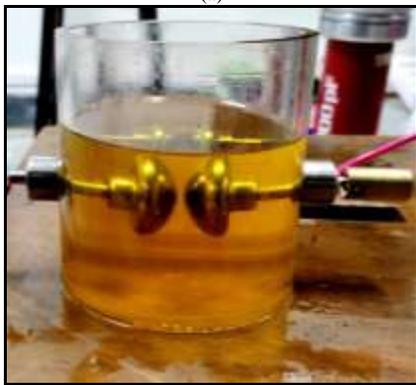
FIGURE 9. (a) Insulation Breakdown Test Equipment (b) Mushroom – Shaped Brass Electrodes in Transformer Oil

Insulation or dielectric breakdown is the point at which the flow of current is stopped. A point just before when the breakdown starts to happen is actually the breakdown strength of that insulation. When that breakdown voltage is achieved then failure of insulation occurs and the material is no longer an insulator as it starts conducting. HIPOT (High Potential) Tester is employed there to check whether the insulation is maintained and if the current is flowing or not. This is the most widely used test for assessing the insulation quality and to test its integrity. Its purpose is to stress the dielectric properties of material under test. It involves a high potential setup with a "Box type and Dry Transformer" or a "Table type and Gas Transformer" or "Cabinet Type and Oil Transformer" and a test specimen is placed in between two electrodes and voltage is raised from zero until breakdown following the guidance in IEC 60243. Measurement conditions are 20 – 25°C temperature and 25 – 27% relative humidity. Breakdown of any material depends chiefly upon its intrinsic properties alongwith other factors such as electrode configuration, surrounding medium, environmental conditions and contact pressure. This phenomenon corresponds to the degradation of insulating properties and also the mechanical deterioration. Figure 9(a) depicts the breakdown test setup.

The mushroom shaped brass electrodes must be of equal length and its contact must be smooth and facing exactly each other which is normal to plane of test sample to avoid any flash outside of the specified area of sample due to irregularities [44]. Electrode chosen were of 20 mm diameter following the standard IEC 60243-1. Sample holder can move back and forth and can be lowered easily in transformer oil as shown in figure 9(b). Oil bath is mandatory otherwise breakdown procedure could lead to many bigger partial discharges and flashovers leading to bigger puncture. Testing in air would cause the breakdown of air as well and it might not cause the intrinsic breakdown of insulation. Every breakdown voltage is displayed on HV measuring unit. The process initiated with some fewer voltage levels and then linearly
