Field Testing & Strength Evaluation of Khushhal Garh Rail cum Road Bridge

ABSTRACT—Old age steel bridges mostly have various problems facing potentially catastrophic result. There is complex array of issues with the railway wrought iron bridges regarding their residual life. Road Cum Rail Bridge near Khushhal Garh is of wrought iron & crosses the River Indus. This bridge is 775 ft. long and consist of four deck truss spans i.e. a 303'-0" anchor arm, a 104'-8" east cantilever (Jand end) , a 261'-0" slung and a 104'-8" west cantilever span (Kohat end). The west cantilever is anchored deep into the rock by means of guys. The upper end of the guys is attached to the top boom while the lower end is connected to anchors of size 10'x 7'-6"x 4'. Roadway is supported on bottom booms of the trusses and railway track is on the top chords. The bridge was opened to traffic on 27th November, 1907. In the course of time this bridge showed some signs of distress, in December 2006, it was decided by the Pakistan Railways Authorities to carry out strength evaluation of this bridge. The task was awarded to a joint venture, Pakistan Railways Advisory and Consultancy Services (PRACS) and Multi-Dimensi

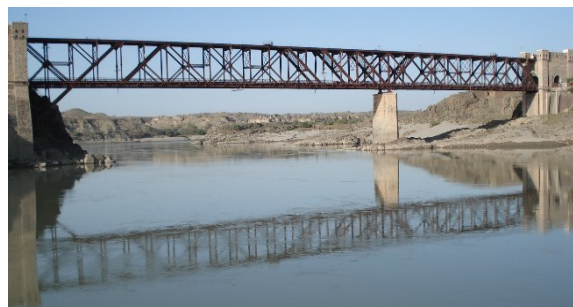
Figure 1 Kohat End Span

The multistory station of Kohat and Punjab is connected through a Rail-cum-Road Bridge which crosses the River Indus on four deck truss spans i.e. a 303'-0" anchor arm, a 104'-8" east cantilever (Jand end) , a 261'-0" slung span and a 104'-8" west cantilever (Kohat end) span (Figure 1).

The west cantilever is anchored deep into the rock by means of guys. The upper end of the guys is attached to the top boom while the lower end is connected to anchors of size 10'x 7'-6"x 4'. These spans carry broad gauge and were designed for standard B live loading of 1903. The

railway track is at top booms and the roadway is at the bottom booms of the spans. The trusses are 45'-0" high and spaced at 20'-0" c/c.

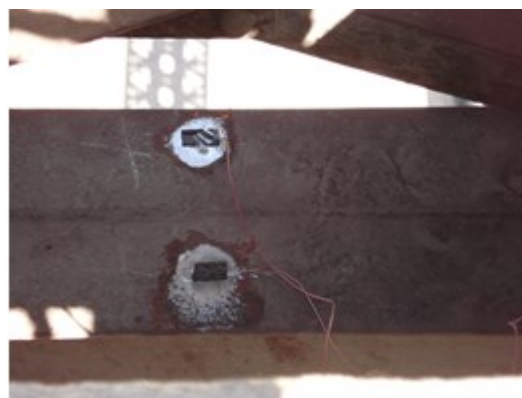
Figure 2 Strain gauges installed at different locations

For this purpose, location of strain gauges and LVDT were fixed for computer analysis. There were 30 strain gauges. The detail of assignment of strain gauges to different member and locations were marked.

A test train of specified capacity was run to take readings on strain gauges installed at different location as shown in Figure 2.

The bridge is modeled as a 3D two span continuous frame structure as shown in Figure - 2. The axial releases are given in members L15L16, U16U17, L26L27 and U25U26. The anchor members L16U16 and L26U26 are simulated as tension members (Zero Compression). The inbuilt capability of software for moving load analysis is used for railway and highway loading.

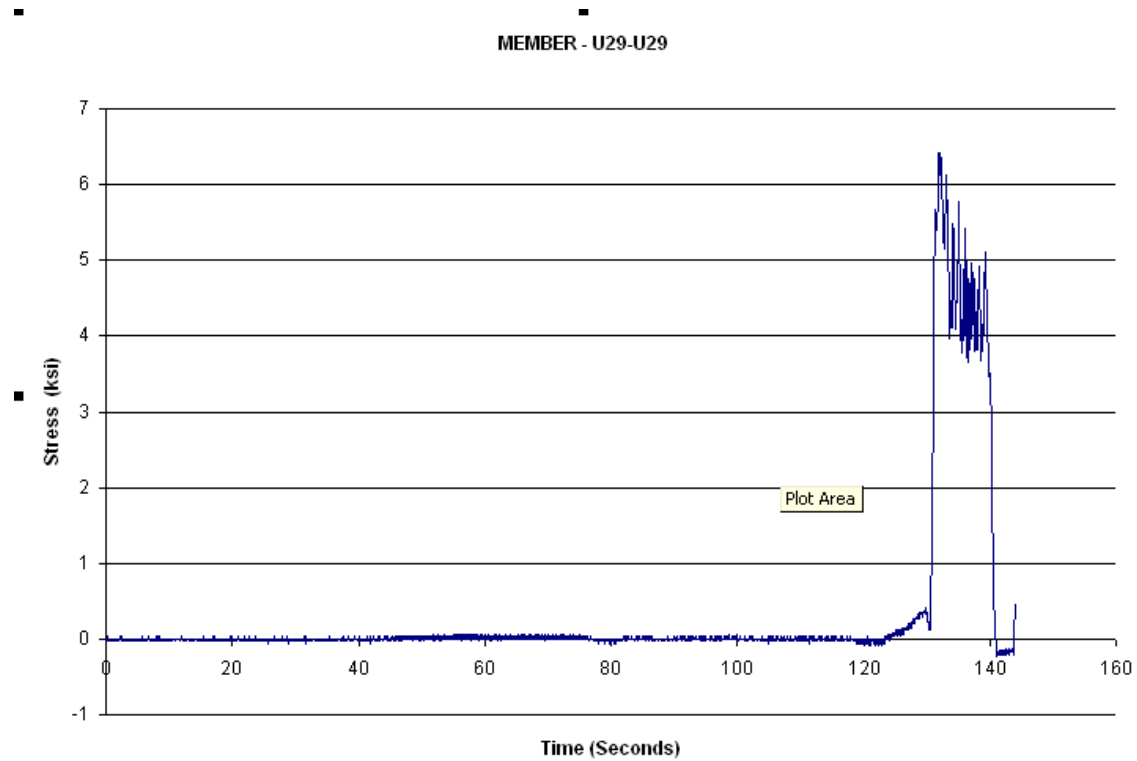
Figure 6.1 Test Train Load Spectrum for Cross Girder U29-U29

Test data has been analyzed and shown in table 5.1 and also graphically represented (fig. 6.1 & 6.2).

(ksi)		(ksi)		(ksi)	
3	0 – 6.45	0.248 31	0- 3.47	0.248 31	0-4.6 31	0.248 31
4	0 – 5.83	0.929 94	0- 3.13	0.929 94	0- 4.17	0.929 94
Total		1.178 25		1.178 25		1.178 25
